TO: Jason Knutson - CGKV Architects

FROM: Bob Lie

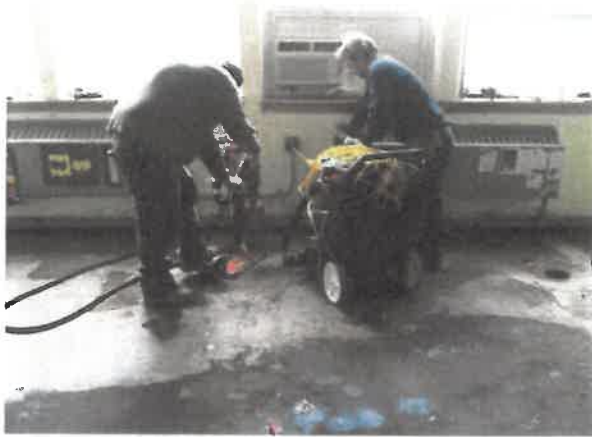
Slab Jacking at Health Office at Spring 2014
Due to hydrant line burst under the building.

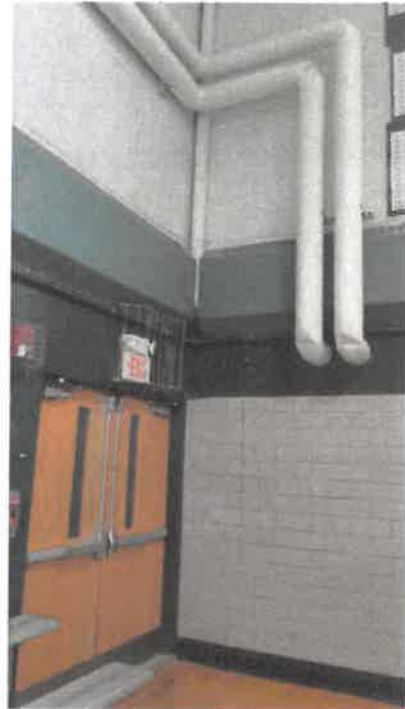
Vertical Crack at NW Gymnasium Corner

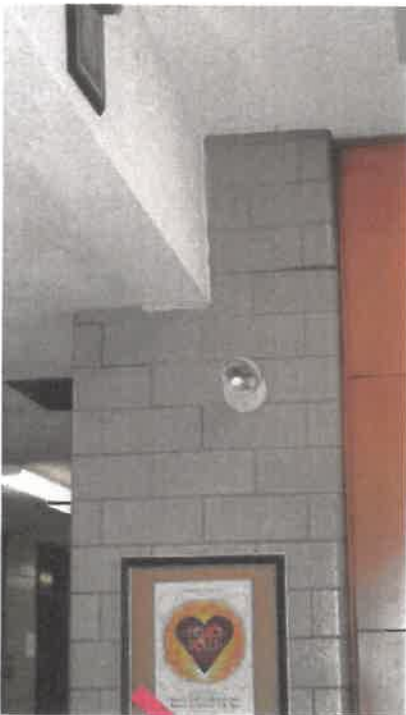
Step Cracking at Glazed Tile Pilaster
Corner of Auditorium

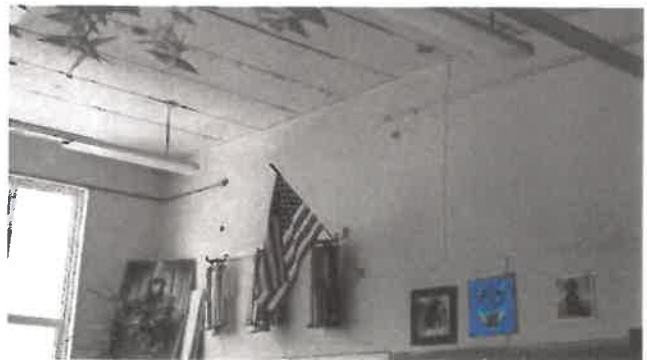
Masonry Vertical Crack at Metal Shop

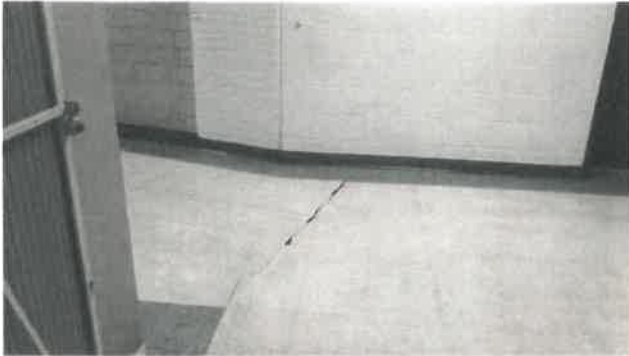
Movement Joint or Crack at Slab on Grade

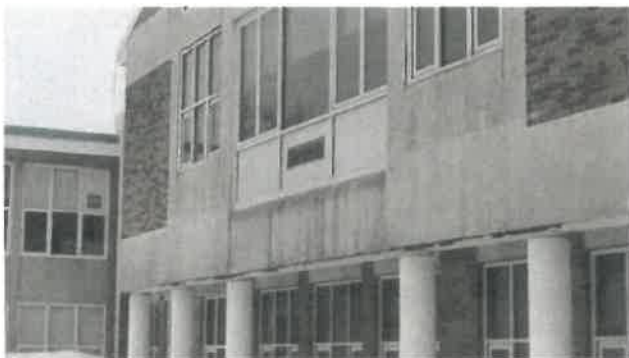
Library Façade at Courtyard
Note corrosion along its edges

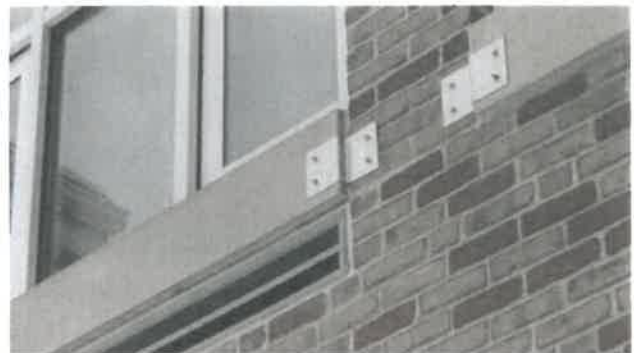
Cast Stone Window Sill Retainer Plate

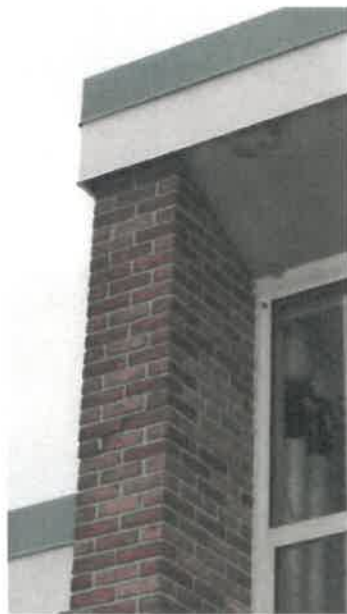
Blade Wall adjacent to Door A3
Note step crack at window mid-height

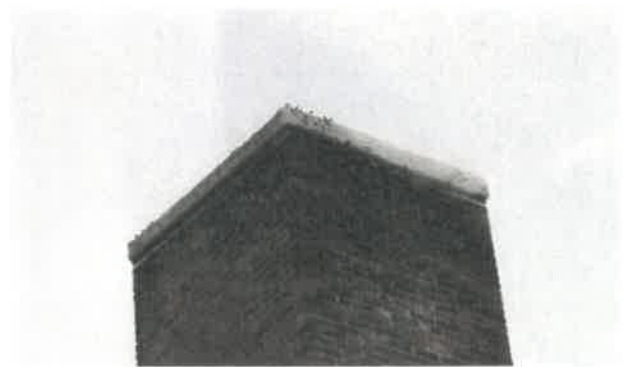
Boiler Room Chimney
Note efflorescence and some loss of mortar at joint.

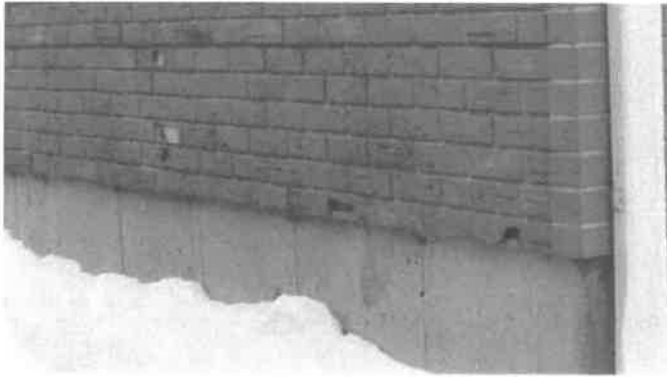
Cafeteria Addition
Note impact damage on "faux brick" plastic façade

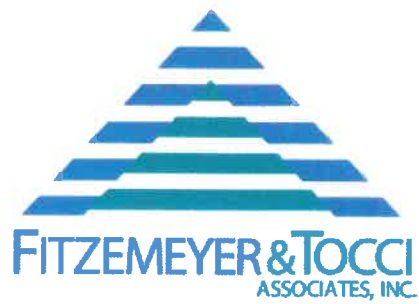
**Pentucket Regional High School
Mechanical, Electrical and Plumbing
Existing Conditions Report**

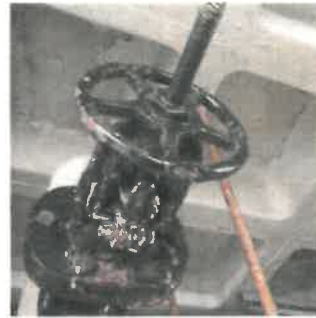
Apparatus Rm – Corroded Gate Valve

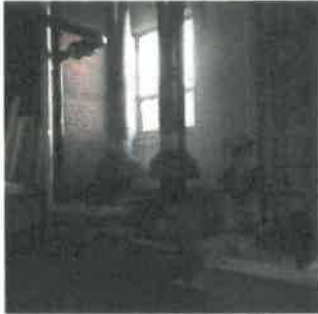
Gas Fired Hot Water Heaters

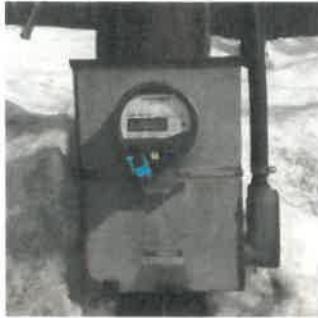
installed within the classrooms which can be a safety hazard for students and faculty. Additionally, maintenance staff have been replacing the Frank Adam and I-T-E panelboards as they fail with new GE panelboards.

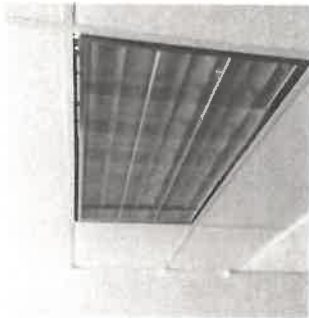
Typical 1993 Addition Lights

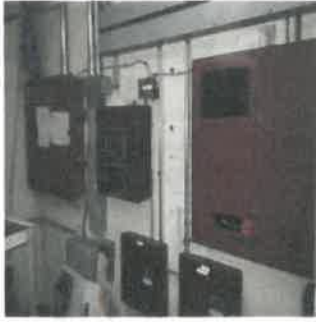
The majority of the fire alarm equipment appeared to be in good physical condition and maintenance staff did not indicate issues with the existing system or devices. However, detectors within Mechanical rooms and within the Gyms appeared to be damaged.

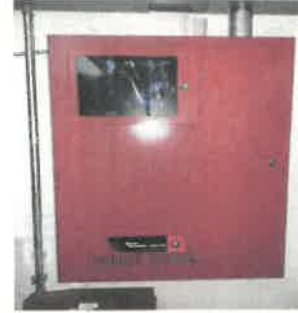
Voice Evacuation Panel
