Existing Conditions Report

**PENTUCKET REGIONAL  
HIGH SCHOOL**

24 Main Street, West Newbury, MA 01985

**March 23, 2015**

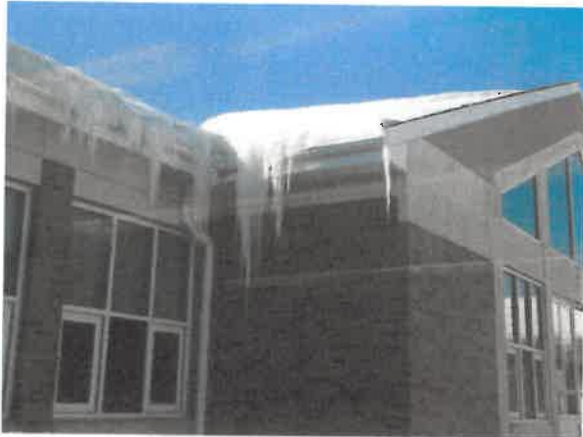
**Figure 08:** Pitched asphalt shingle roof at 1993 classroom wing.

The Aulson Company inspected the asphalt shingle roof in November 2014 and found that the shingles are in need of replacement due to cracking and splitting. The District reports active leaks under certain weather conditions in this portion of the school.

At the time of CGKV's visit to the school, we observed significant ice-damming at the perimeter of the 1993 classroom wing. Deteriorated shingles, active leaks, and ice dams could all result from the original design and/or construction of the roof system at this portion of the facility. CGKV accessed the attic space to the south of the media center and found it to be relatively warm despite outdoor air temperatures being well below freezing. This suggests that the attic space may be inadequately ventilated. The lack of a vapor retarder as part of the insulation layer may also negatively impact the performance of the roof assembly. Lastly, according to the 1993 drawings, the roof assembly does not include an ice and water shield, which, at minimum, would normally be located at the lowest three to four feet of the roof perimeter.

Replacement of asphalt shingles at the 1993 classroom wing will require care to ensure that existing fire-proofing applied to the roof structure and to the underside of the roof deck is not dislodged.

- Asphalt shingles at the 1993 classroom wing are in need of replacement due to cracking and splitting. Additionally, roof replacement should address possible problems with ice dams, attic ventilation, and thermal and moisture control.

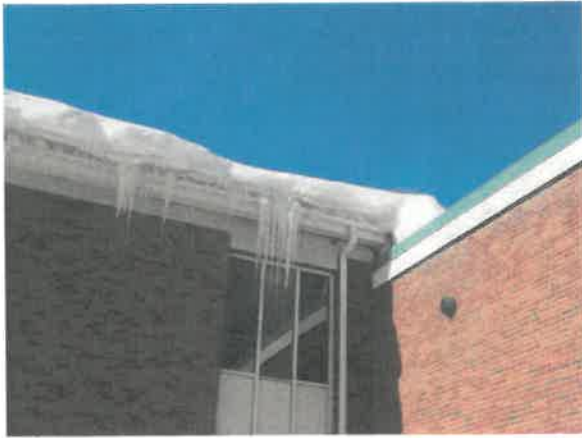
Ice dams and icicles at the perimeter of the 1993 classroom wing are a danger to pedestrians below. The District installed caution tape at one set of exterior doors directly below an ominous group of icicles to prohibit use of those doors except in the case of emergency.

**Figure 10:** Icicles above egress doors at 1993 classroom wing.

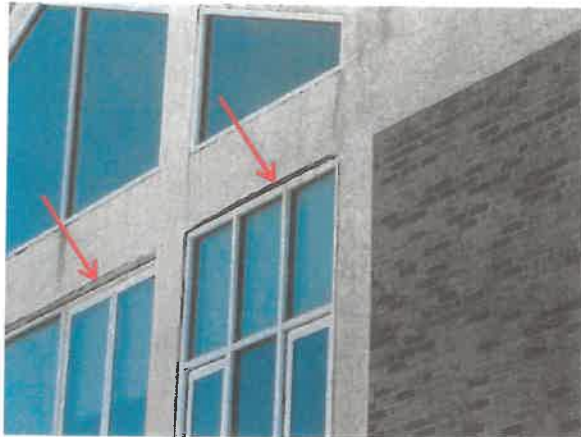
There are significant problems with water intrusion at this exterior elevation, which can be clearly seen at damaged interior finishes within the media center. Similarly, exterior edges of the cement plaster assembly are deteriorated and rusting. This condition warrants further exploration. Unchecked and continuing water intrusion can further deteriorate the exterior wall structure and possibly lead to the introduction of mold into the wall assembly.

**Figure 12:** Evidence of water intrusion at perimeter of windows to cement plaster exterior finish at 1993 classroom wing north elevation.

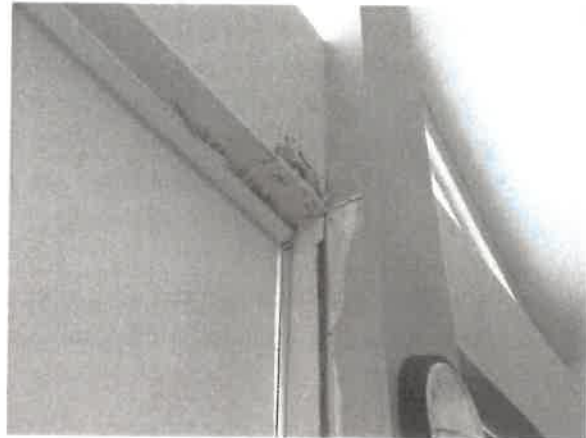
**Figure 13:** Damaged interior finishes at 1993 media center.

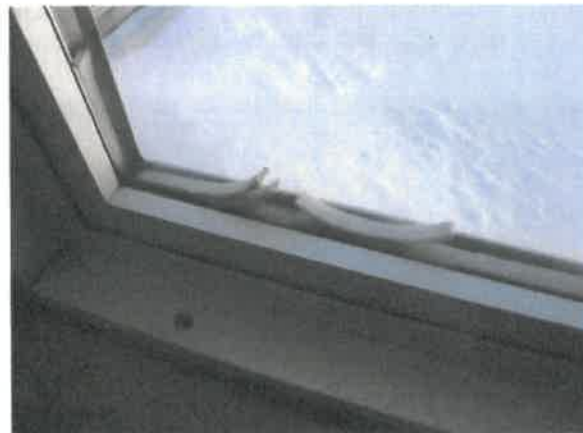
**Figure 17:** Deteriorated gaskets at aluminum windows.

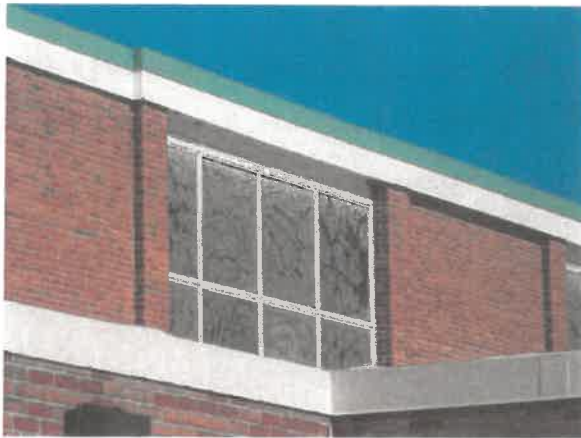
CGKV observed issues with south-facing windows at the 1956 gymnasium. Some sort of glazing treatment has deteriorated and resulted in a crazed pattern on the surface of the glass. Physical Education faculty report that uncontrolled glare at these windows disrupts athletic activities inside the gym.

**Figure 18:** Deteriorated glazing treatment at south-facing windows in the 1956 gymnasium.

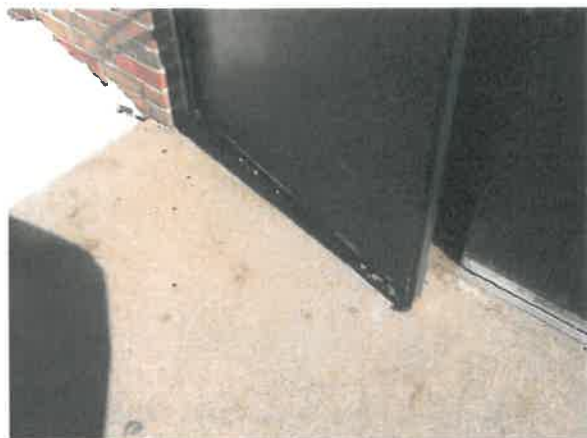
The fit and operation of existing exterior doors is problematic. Weather seals are ineffective, either through general deterioration or through cracking and sagging of

door and frame components. Conditions at the southwest exterior door at the 1993 gymnasium have made that door virtually inoperable, raising serious concerns about the available means of effective egress from that space.

**Figure 21: Damaged egress door from 1993 gymnasium.**

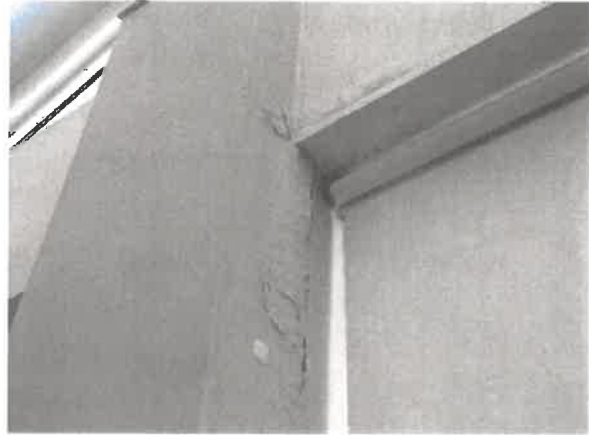
water damage are visible at the exterior wall. (See Figure 34.)

**Figure 34:** Damaged gypsum wall board at media center exterior wall.

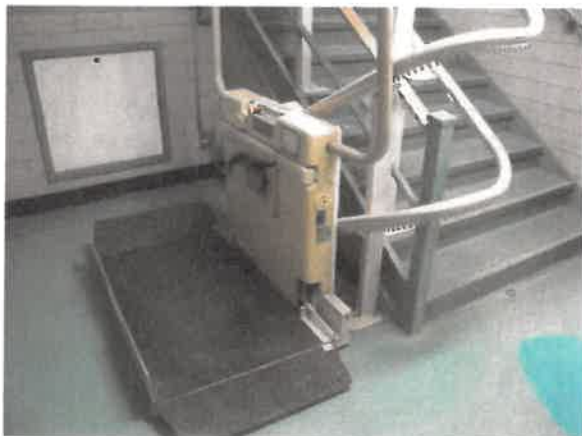
**Figure 39:** Inoperable stair lift at 1956 "Junior wing."

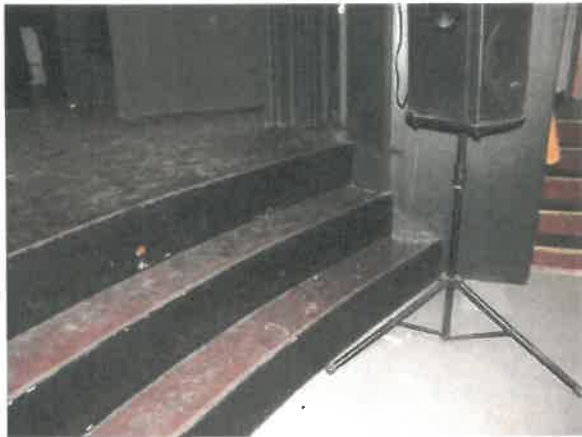
Despite a number of beneficial improvements constructed during and after the 1993 project, Pentucket High School is not fully accessible to the extent that would be required for a new building. [See Section IV.] The local building official has deemed the stair lift at the 1956 “Junior wing” to be a hazardous impediment to the means of egress stair and has prohibited its use, thus making this classroom wing inaccessible to wheelchair users. The auditorium includes wheelchair seating areas, but there is no accessible route to the stage or the controls platform. The platform lift at the former shop wing provides a direct path to two of the three instruction spaces, but access to the music practice room requires passing through the adjacent art room.

**Figure 41: Non-accessible steps to auditorium stage.**

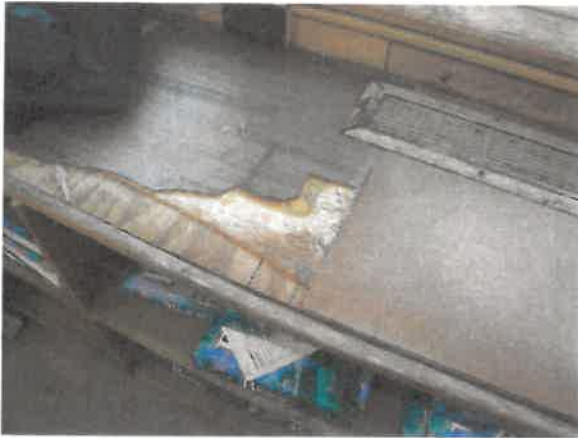
Most typical 1956 classrooms continue to utilize cabinets, shelving, work stations, and chalkboards that date back to the school’s original construction. Many of these amenities have held up fairly well over 60 years, but finishes, hardware, and controls are quite worn and have surpassed their expected service life. This is especially true at classroom shelving units, where the original linoleum countertop surface is damaged and missing at a number of locations. The home economics kitchen is still furnished with cabinets and counters from the 1950s. Science lab work stations are also original, including asbestos-containing countertops, and are outdated.

**Figure 42:** Damaged countertop surfaces at 1956 classroom shelving units.

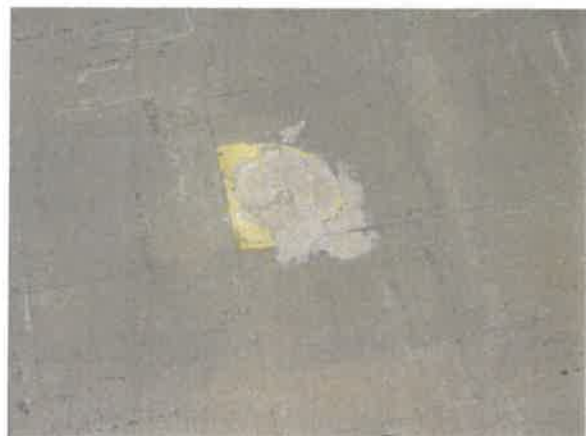
The most prevalent non-friable ACM in the building is vinyl asbestos floor tiles, which show wear but are otherwise in good to fair condition. Some areas of vinyl asbestos flooring have been covered over with newer flooring surfaces such as carpet or vinyl tiles. After the major flood that occurred in the “Junior wing” in 2014, repairs to the building interior included removal of existing vinyl asbestos floor tiles at the Ground Floor in that section of the building. Cement-asbestos panels can also be found in transoms above many corridor doorways.

**Figure 48:** Damaged and patched vinyl asbestos floor tiles.

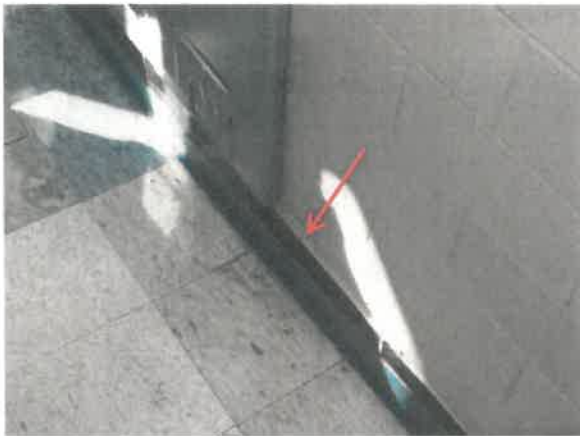
- The 2014 rupture of a six inch diameter hydrant line under the 1956 “Junior wing” created a significant flood that disturbed the underlying bearing soil and caused the concrete slab and adjacent walls to settle. The slab and foundation were stabilized through compaction grouting, but evidence of displaced masonry walls is still visible.
- Stress release cracks are visible at a number of masonry walls, including the 1956 gymnasium, the 1956 auditorium, and the former 1956 metals shop.

**Figure 49:** 1956 masonry wall construction displaced by the force of water and silt from 2014 flood event.

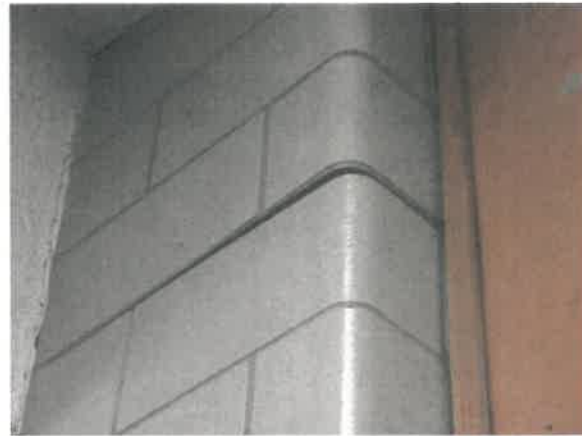
**Figure 50:** Stress release crack at 1956 auditorium.

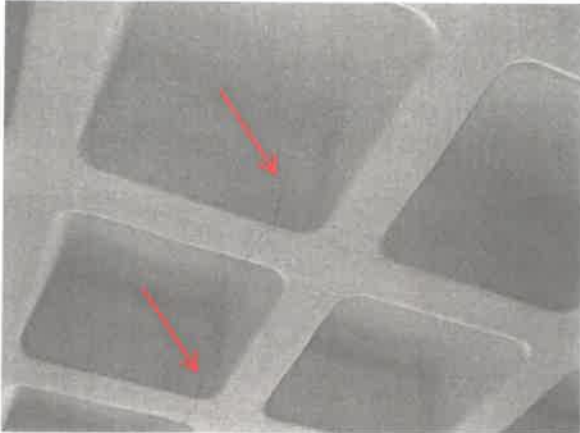
- Shrinkage cracks in the First Floor cast in place concrete waffle slab are visible at several locations.
- Pre-cast concrete window sills installed at the 1993 classroom wing were apparently insufficiently anchored to the building structure and exhibited movement over the years. These sills have since been anchored to the adjacent brick wall with stainless steel plates.

**Figure 51:** Shrinkage cracks at 1956 cast in place concrete waffle slab.

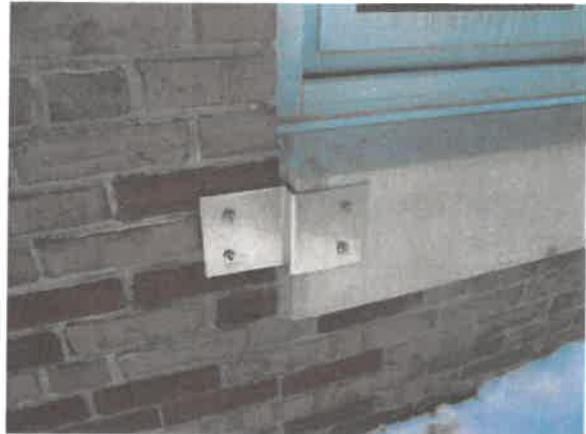
**Figure 52:** Stainless steel brackets installed to anchor 1993 pre-cast concrete window sills.

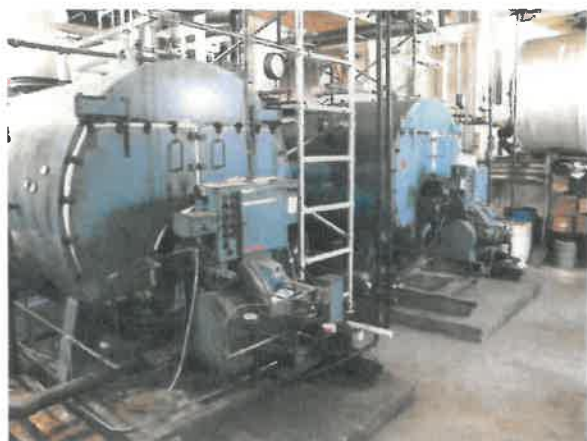
The heart of the HVAC system is the pair of fire tube steam boilers, installed ca. 1993, located in the boiler room. According to F&T, both boilers are weathered, in poor condition, and are nearing the end of their useful life. One of the boilers is in worse shape than the other and is merely serving as a back-up at this time.

**Figure 53:** Existing boilers.

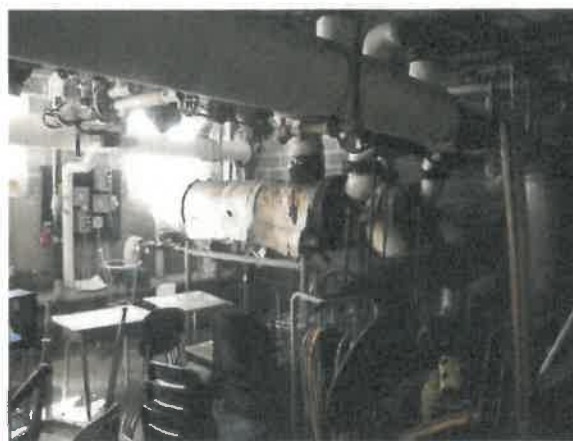
original 1956 heat exchangers are in very poor condition, and gate valves are corroded and do not appear to be operable. According to F&T, equipment in the Apparatus Room, dating back to 1956, appears to be in imminent danger of possible failure, which could cause a large portion of the High School to be without heat.

**Figure 54:** Existing 1950s vintage HVAC equipment in the Apparatus Room.

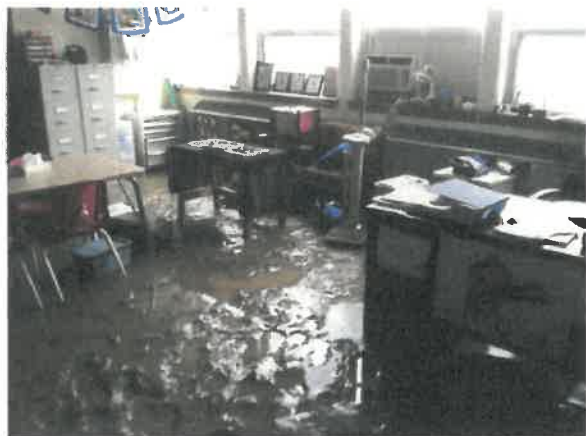
The 6" water main feeding the high school runs 1,600 feet from State Highway 113 to and under the building. This main has failed at multiple points over the years, including under the parking lot ca. 2000, under the front entrance drive ca. 2005, under the "Junior wing" in April 2014, and under State Highway 113 in January 2015. Several sections of this pipe have been capped and abandoned, leaving the campus without the service of one fire hydrant on the north side of the building.

Figure 58: Flood damage at 1956 “Junior wing” as a result of April 2014 water main break.

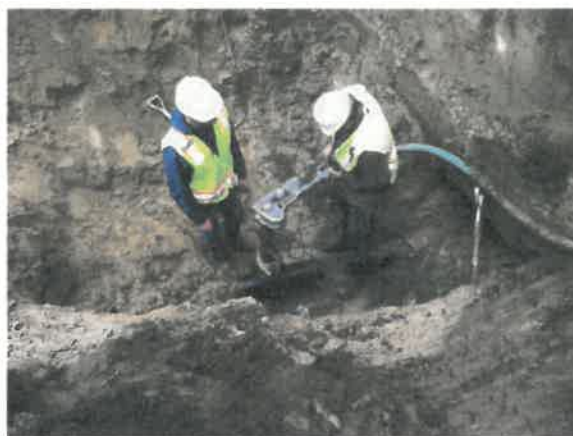
Figure 59: Repair work at April 2014 water main break.

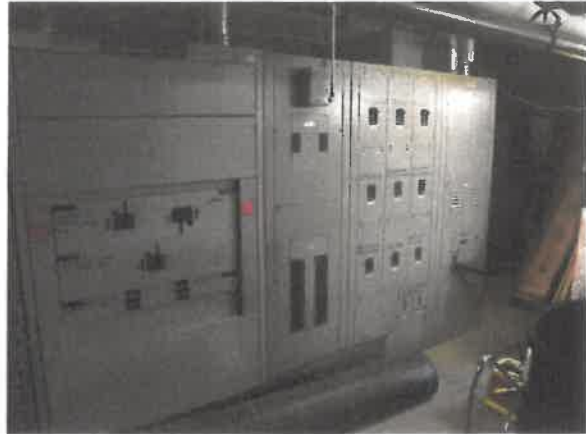
The original 1956 main switchboard is still in use, is in poor condition, and is well past its useful life of 25 years. According to F&T, this original switchboard appears to be in imminent danger of possible failure. As part of the 1993 addition and renovation project, an additional section was added to the original switchboard to distribute power to the newer sections of the school. Though in fair physical condition, this newer equipment is getting close to the end of its useful life.

**Figure 61:** Original 1956 main switchboard (right) and added 1993 switchboard in Apparatus Room.

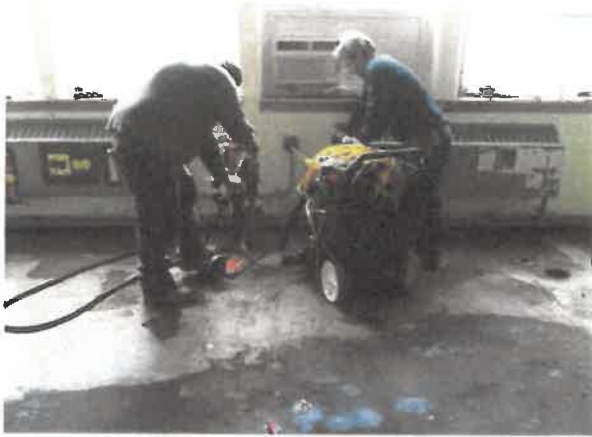
**Slab Jacking at Health Office at Spring 2014  
Due to hydrant line burst under the building.**

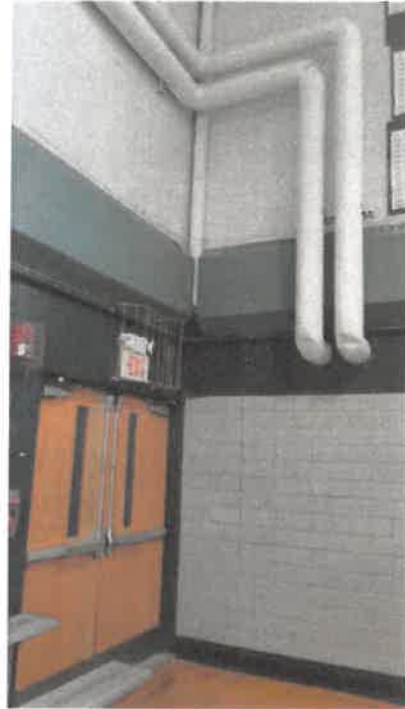
**Vertical Crack at NW Gymnasium Corner**

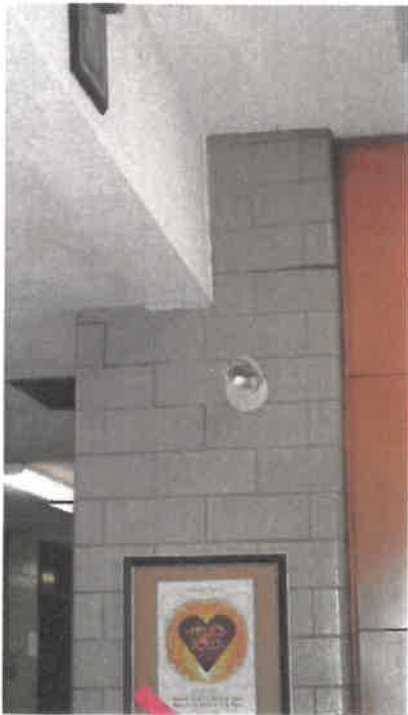
**Step Cracking at Glazed Tile Pilaster  
Corner of Auditorium**

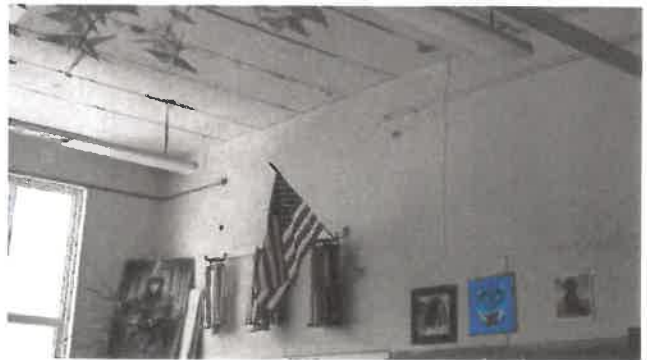
**Masonry Vertical Crack at Metal Shop**

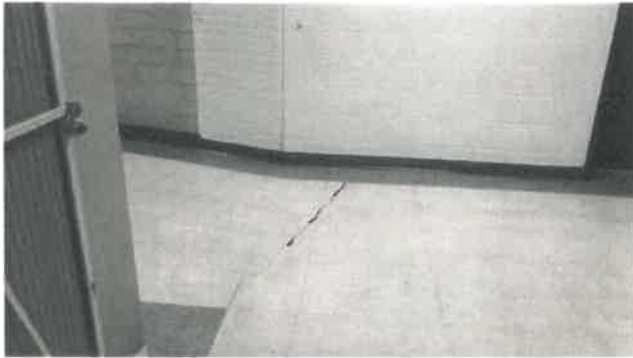
**Movement Joint or Crack at Slab on Grade**

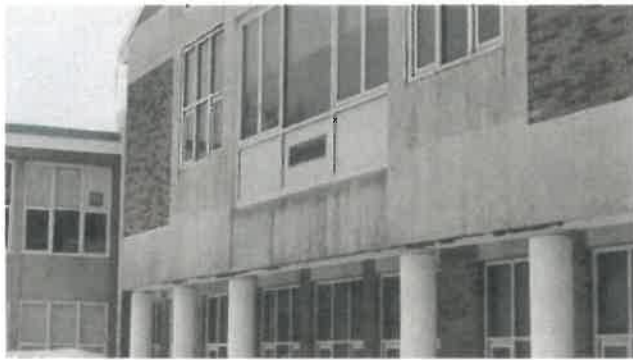
**Library Façade at Courtyard**  
**Note corrosion along its edges**

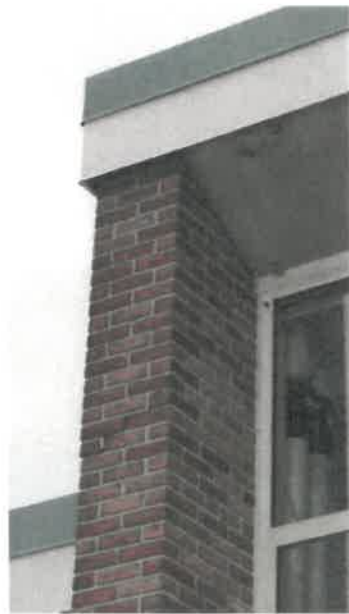
**Blade Wall adjacent to Door A3**  
**Note step crack at window mid-height**

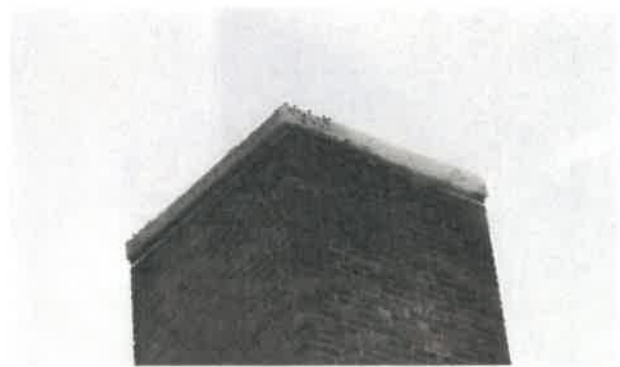
**Boiler Room Chimney**  
**Note efflorescence and some loss of mortar at joint.**

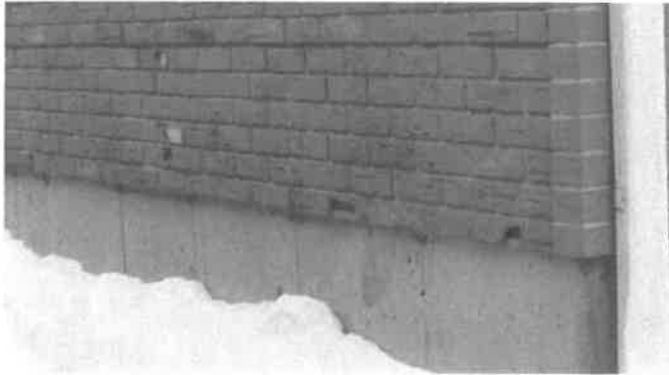
**Cafeteria Addition**  
**Note impact damage on "faux brick" plastic façade**

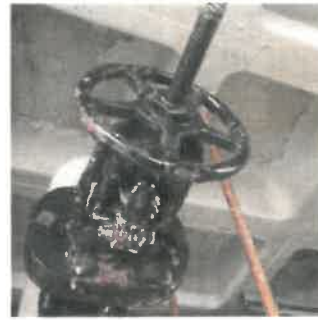
**Apparatus Rm – Corroded Gate Valve**
