Existing Conditions Report

**PENTUCKET REGIONAL  
HIGH SCHOOL**

24 Main Street, West Newbury, MA 01985

**March 23, 2015**

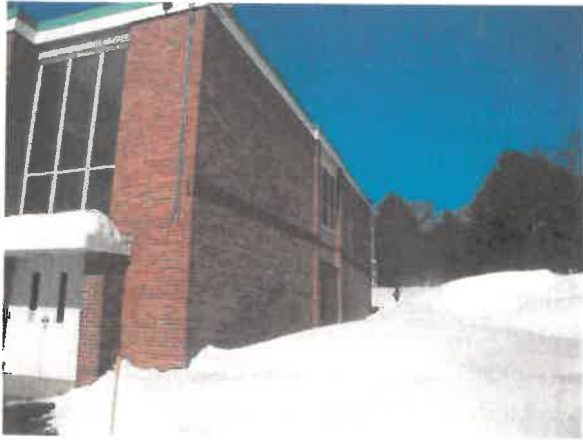
The rupture of a 6" water main below the "Junior wing" in April 2014 caused significant damage to that section of the building as well as to the modular classrooms. As a direct result, the modular classroom wing was removed.

**Figure 07:** East end of the 1956 “Junior wing” where modular classrooms were removed in 2014.

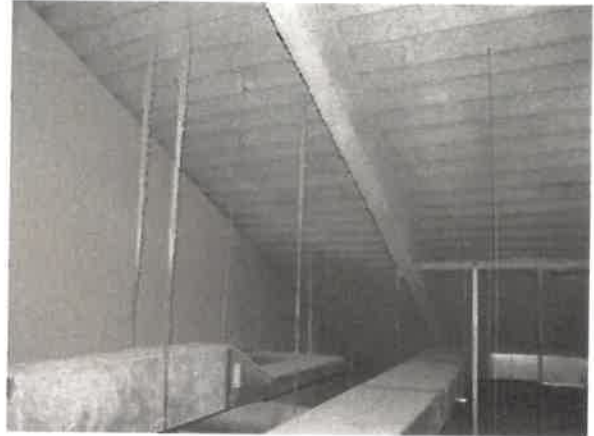
**Figure 09:** 1993 classroom wing attic space. [Note sprayed on fire-proofing.]

The Aulson Company inspected the asphalt shingle roof in November 2014 and found that the shingles are in need of replacement due to cracking and splitting. The District reports active leaks under certain weather conditions in this portion of the school.

At the time of CGKV's visit to the school, we observed significant ice-damming at the perimeter of the 1993 classroom wing. Deteriorated shingles, active leaks, and ice dams could all result from the original design and/or construction of the roof system at this portion of the facility. CGKV accessed the attic space to the south of the media center and found it to be relatively warm despite outdoor air temperatures being well below freezing. This suggests that the attic space may be inadequately ventilated. The lack of a vapor retarder as part of the insulation layer may also negatively impact the performance of the roof assembly. Lastly, according to the 1993 drawings, the roof assembly does not include an ice and water shield, which, at minimum, would normally be located at the lowest three to four feet of the roof perimeter.

Replacement of asphalt shingles at the 1993 classroom wing will require care to ensure that existing fire-proofing applied to the roof structure and to the underside of the roof deck is not dislodged.

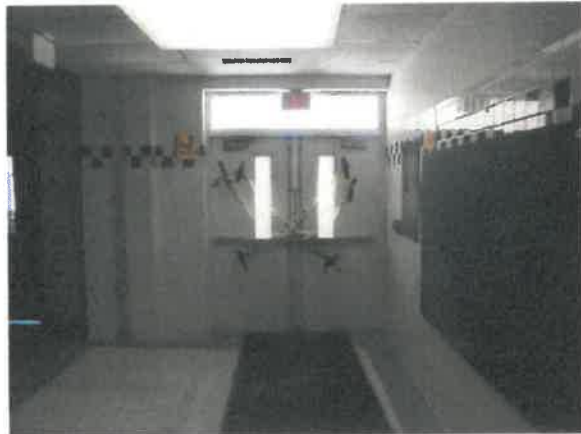
**Figure 11:** Caution tape at 1993 egress doors below icicles.

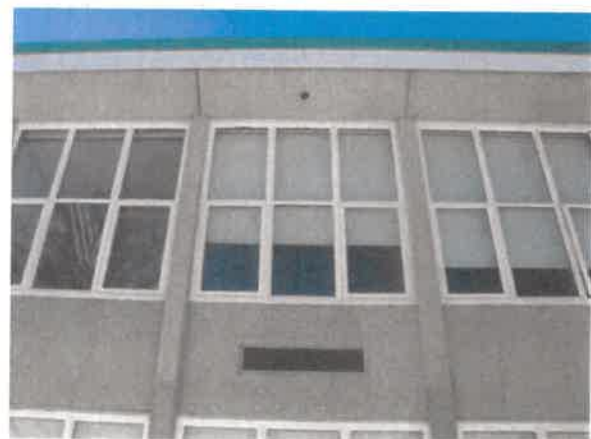
Existing exterior walls at the 1956 classroom wings are constructed of face brick with CMU back-up, or, at the primary elevations, of pre-cast concrete mullions infilled with window units (replaced ca. 1993) and pre-cast concrete “Mosai” panels. “Mosai” panels are pre-cast concrete wall panels featuring an exposed aggregate on the outside surface. They were frequently used in building projects from the 1940s through the 1960s, and feature in many buildings designed by Korslund, Le Normand & Quann. Exterior brick, pre-cast concrete mullions, and “Mosai” panels at Pentucket Regional High School appear to have held up well.

**Figure 15:** Pre-cast concrete mullions, “Mosai” panels, and replacement aluminum windows.

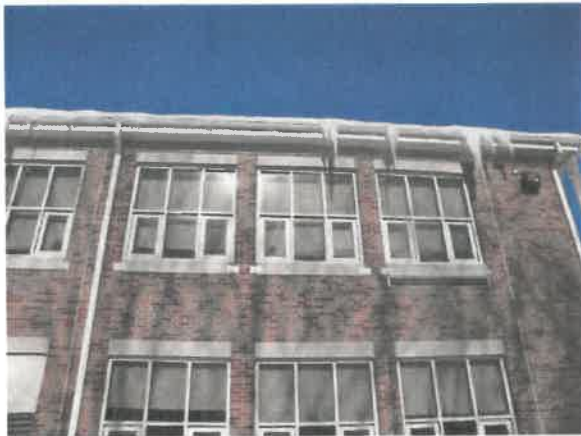
All windows from the original 1956 building were replaced as part of the 1993 renovation and addition project. The existing windows are aluminum-framed with 1" insulated glass. Operable sashes are typically project-out casements. Since 1993, the District has installed custom interior insect screens at many locations, including wicket screens to access latch hardware. The District did not report any pervasive concerns with existing exterior window systems. CGKV did observe some deterioration of gaskets at insulated glass, though these defects did not appear to affect the insulated glass unit seals.

**Figure 16:** Typical aluminum windows at 1993 classroom wing.

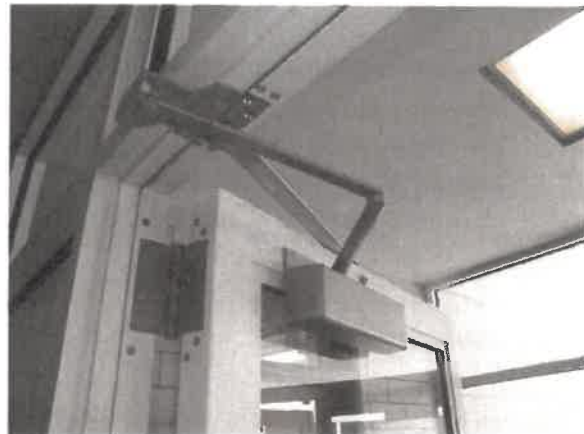
Like the exterior windows, all exterior doors were replaced as part of the 1993 renovation and addition project. Primary entrance doors are aluminum-framed. Other doors are hollow metal with hollow metal frames. Exterior doors are in generally poor condition, unsuitable for the degree of use they've seen over nearly twenty years. Aluminum doors and frames have suffered the most, with screwed connections loosening over time. Door hardware is also deteriorated and is an ongoing maintenance concern. The District has found it necessary to supplement original ca. 1993 overhead door closers with new surface-mounted closers.

**Figure 20:** Original (ca. 1993) and supplemental overhead door closers/stops.

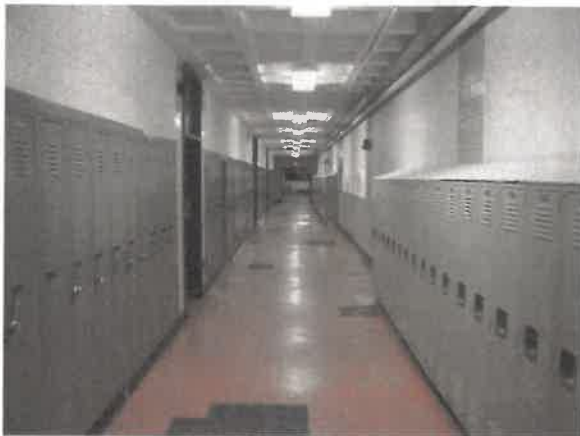
The most prevalent non-friable ACM in the building is vinyl asbestos floor tiles, which show wear but are otherwise in good to fair condition. Some areas of vinyl asbestos flooring have been covered over with newer flooring surfaces such as carpet or vinyl tiles. After the major flood that occurred in the “Junior wing” in 2014, repairs to the building interior included removal of existing vinyl asbestos floor tiles at the Ground Floor in that section of the building. Cement-asbestos panels can also be found in transoms above many corridor doorways.

**Figure 47:** Vinyl asbestos floor tiles at typical 1956 corridors.

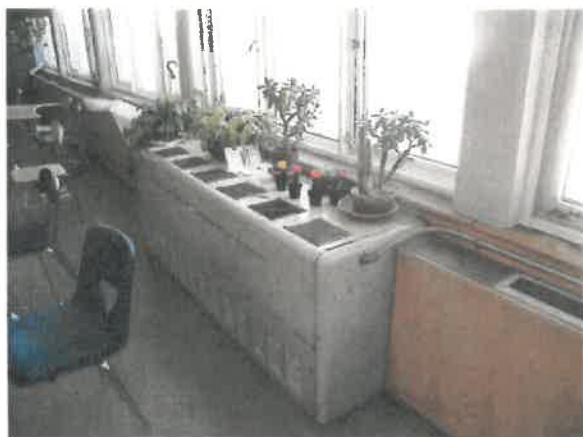
Terminal units - such as unit heaters, finned tube radiators, and unit ventilators - deliver heat (and in some cases fresh air) to individual spaces within the school. The 1956 sections of the building continue to rely, in most cases, on terminal units that are nearly sixty years old. The District noted that replacement parts are not available for the 1950s vintage unit ventilators and that repair work requires customization or aftermarket retrofitting. Even equipment installed as part of the 1993 project is approaching its 20-25 year life expectancy.

**Figure 55:** Original unit ventilator in 1956 classroom.

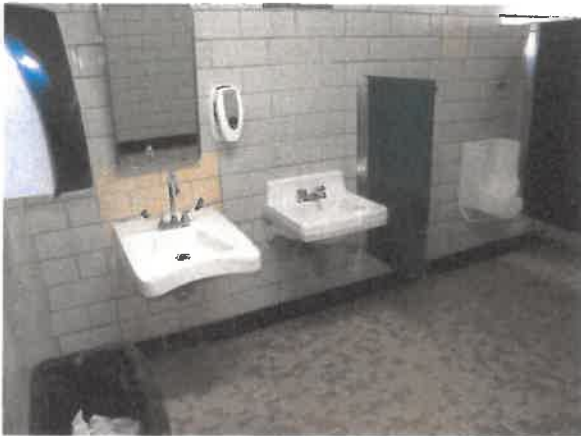
**Figure 56:** Plumbing fixtures replaced at 1956 toilet room.

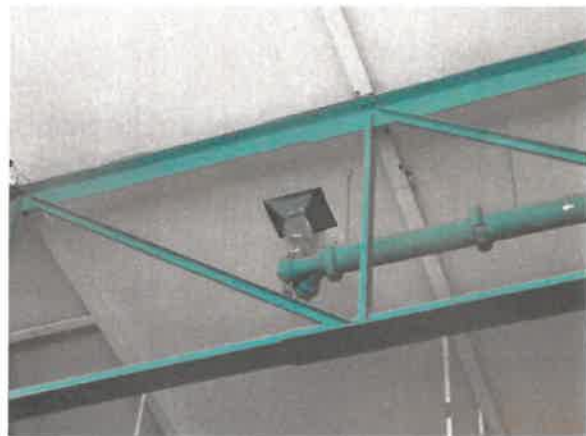
F&T's observations found the gas fired domestic hot water heaters and hot water tanks to be in need of replacement due to age and condition. Piping that dates back to the 1950s is corroded and leading to sporadic pipe point failures. Most of the plumbing fixtures were replaced as part of the 1993 project and appear to be in mostly satisfactory condition. Visible roof drainage system components appeared to be in poor condition. Roof drains in the 1956 gymnasium are reported to leak and drip condensation, causing damage to the wood flooring below.

**Figure 57:** Existing roof drain at 1956 gymnasium.

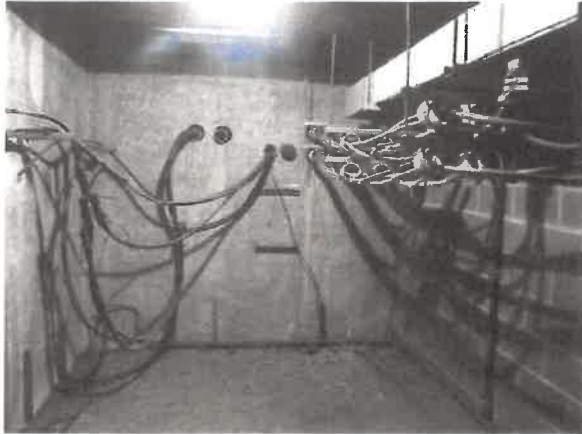
The primary electrical service cable enters Pentucket Regional High School through the utility vault located in the Apparatus Room. This primary cable then splits, with one branch routed to a transformer that serves the high school and the other routed to the middle school. The configuration of electrical service and the use of just one primary meter make it impossible to determine the specific electrical demand of the high school versus the middle school. The primary cables are original to the 1956 construction of the building and are in poor physical condition.

**Figure 60:** Existing primary electrical service in Apparatus Room utility vault.

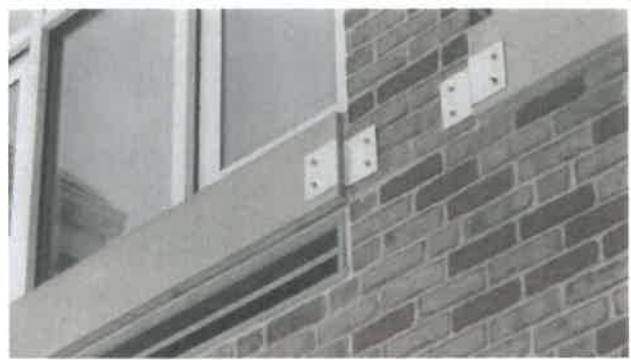
**Cast Stone Window Sill Retainer Plate**

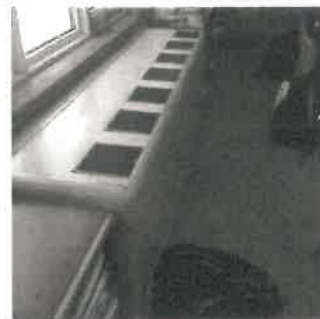
**Unit Ventilator (1956)**

- Many terminal units (unit heaters, radiators, unit vents) in the 1956 portions of the school are original, are in poor condition, and are very difficult to service and repair.

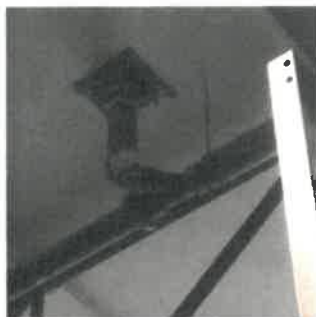
The roof drainage system, where visible, appeared to be in poor condition. The exposed roof drains within the Gymnasium showed signs of corrosion and failure; and appeared to have needed significant repair in order to maintain operation.

Gymnasium Roof Drain Connection

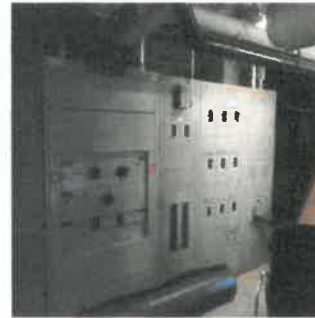
- The original 1956 main switchboard is still in use, is in poor condition, and is well past its useful life of 25 years. According to F&T, this original switchboard appears to be in imminent danger of possible failure.

Main Switchboard

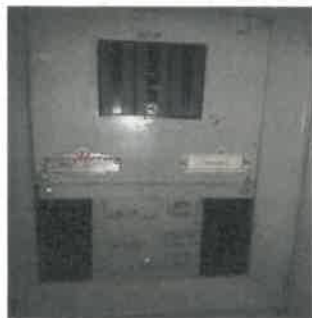
installed within the classrooms which can be a safety hazard for students and faculty. Additionally, maintenance staff have been replacing the Frank Adam and I-T-E panelboards as they fail with new GE panelboards.

Frank Adam Panelboard

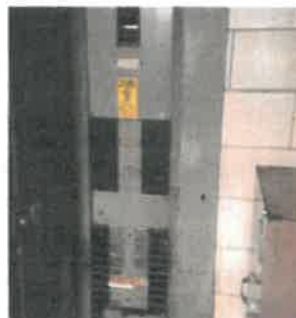
Gym I-T-E Panelboard

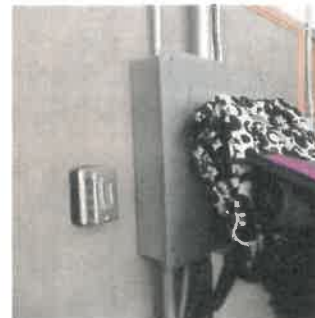
Classrooms within the 1956 construction only included a single receptacle branch circuit and typically only 2 duplex receptacles, which does not provide adequate branch circuitry or electrical infrastructure within classrooms for to accommodate modern classroom power requirements. Due to the lack of electrical infrastructure, maintenance staff have installed panelboards within classrooms in order to provide power to new receptacles for projectors, general purpose receptacles and computers. The panelboards within classrooms are often being blocked by debris not allowing for proper working space clearance in front of the equipment. The panelboards are also not properly protected from damage when

Typical Classroom Panelboard

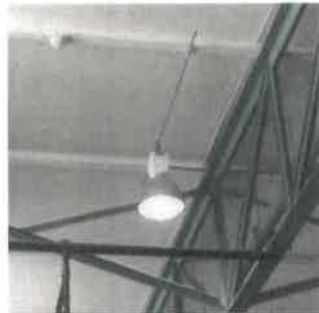
The majority of the fire alarm equipment appeared to be in good physical condition and maintenance staff did not indicate issues with the existing system or devices. However, detectors within Mechanical rooms and within the Gyms appeared to be damaged.

**Gym Smoke Detector**
